Coast Care Update for the Pukehina Community November 2023

Repair work required:

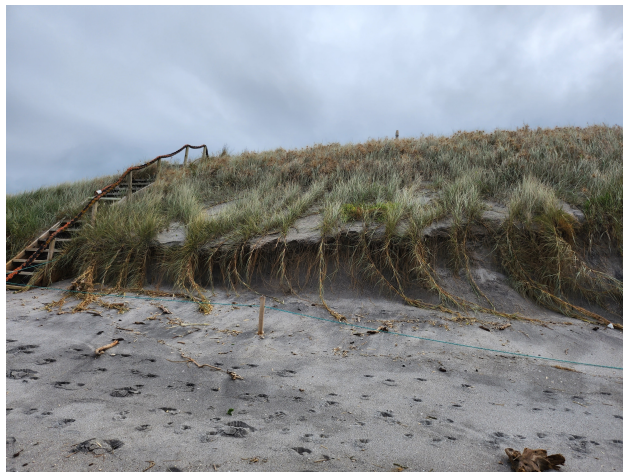
141-165 Pukehina Parade (230m): *Parts of this area were repaired earlier this year but there has been further damage in the recent events (Figure 1)*

The key objective of the proposed dune repair is simply to reinstate the eroded dune in front of the most damaged properties and dwellings. As per earlier work, the push-up repair simply provides a sacrificial dune to mitigate future erosion. It is not a permanent solution to the erosion hazard
